# Manhole Inspection Summary

Manhole # S15AA1010MH

Insp Date: **3/14/07 2:47 PM**

**Location** Address: **2614 VIOLET AVE**

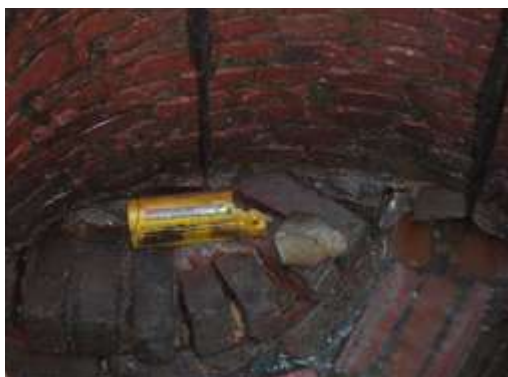
Defect

**Bench** ☒ Exists Material: **Brick** ☐ Parged ☒ **Debris** (not Condition related)

**Surcharge** ☒ **Evidence Of Surcharge** Depth: **1** (ft.) ☐ Active Surcharge Present

Evidence of surcharge - Bench debris.

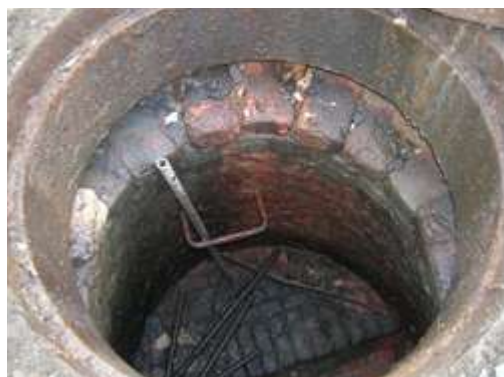
Defect

Condition: ☐ Sound ☐ Cracked ☐ Root Intrusion ☒ **Deteriorated** ☐ Leaks ☐ Debris

Condition: ☐ Sound ☐ Cracked ☒ **Root Intrusion** ☒ **Deteriorated** ☐ Leaks ☐ Debris

Bench and Channel deterioration.

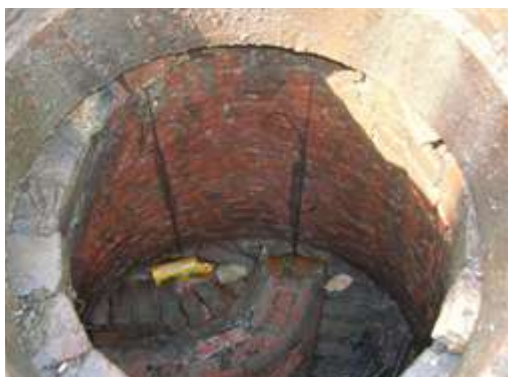
Defect

**Frame** Offset: **5** (in.) Condition: ☐ Sound ☐ Cracked ☒ **Leaks**

Condition: ☐ Sound ☐ Cracked ☒ **Root Intrusion** ☒ **Loose Brick** ☐ Deteriorated

Infiltration: ☐ None ☒ **Joint** ☐ Cracks ☒ **Mortar** ☒ **Roots** ☐ Wall

Frame leaks. Frame offset. Adjustment deterioration, loose brick, root intrusion and infiltration. Corbel and Barrel

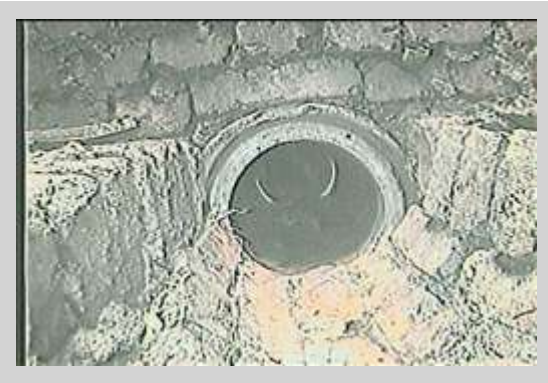
### 8 in. Circular Gravity Sewer Pipe Out @ 12 O'Clock

Barrel deterioration and infiltration. Channel deterioration and root intrusion.

Infiltration: **Evidence** Pipe Seal Cond: **Unknown**

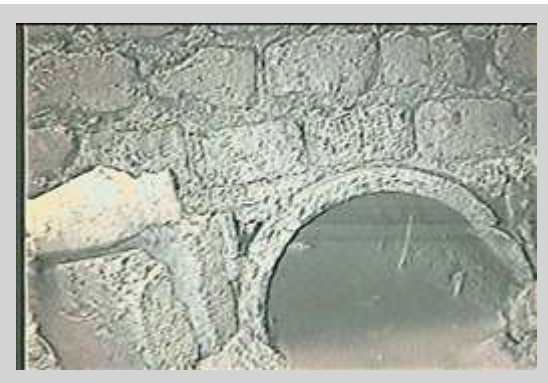
### 8 in. Circular Gravity Sewer Pipe In @ 3 O'Clock

Barrel deterioration and infiltration.

Infiltration: **Evidence** Pipe Seal Cond: **Broken**
